Manhole Inspection Summary

Manhole # S13EE1001MH

Insp Date: **1/26/09 1:10 PM**

Location Address: **4052 PARK HEIGHTS**

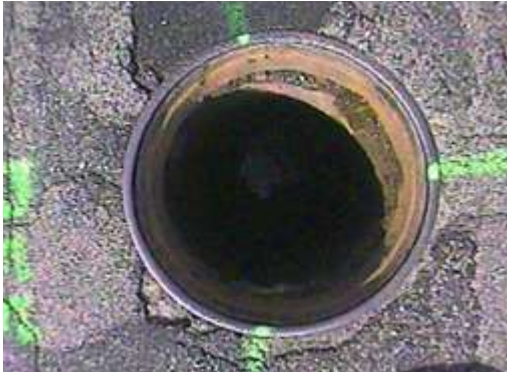
Defect 2

Offset: **1** (in.)

FRAME OFFSET

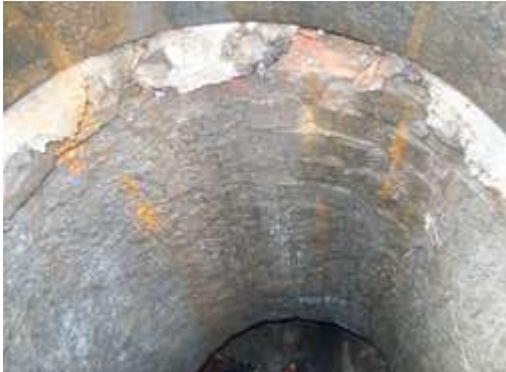
Defect 1

Condition: ☐ Sound ☐ Cracked ☐ Root Intrusion ☒ **Loose Brick** ☐ Deteriorated

CHIMNEY LOOSE BRICKS

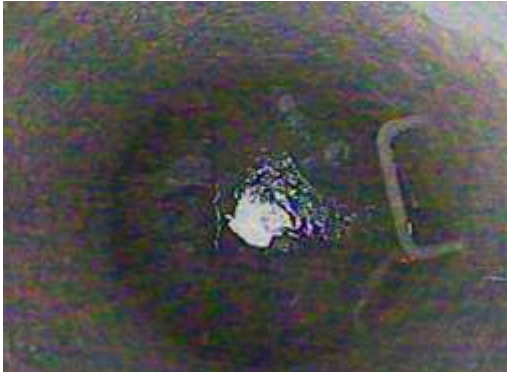
Count: **3** Missing: **1** ☒ **Corroded**

CORRODED STEPS

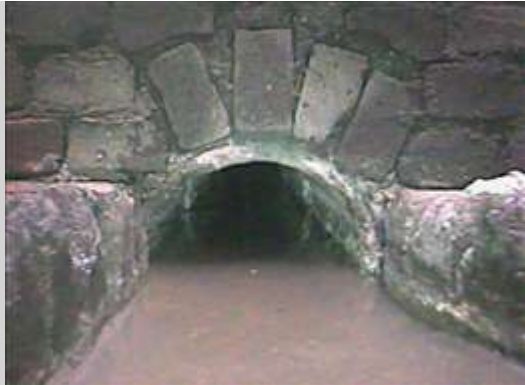
12 O'Clock Outflow

DEBRIS IN CHANNEL

Pipe Height: (in.) Direct
Pipe Material: **Clay** ☐ Pipe Lined
Invert Depth: **8.52** (ft.) Flow Characteristics: **Slow**
Deposits: ☐ None ☐ Mud ☒ **Sludge** ☐ Debris ☐ Grease
Silt Depth: **2** (in.) Deposits Extent: **Light**
Infiltration: **None** Pipe Seal Cond: **Sound**

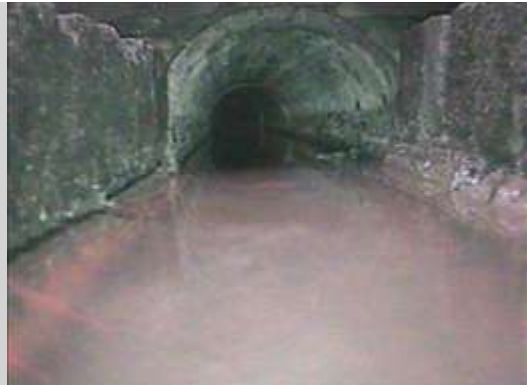
6 O'Clock Inflow

DEBRIS IN CHANNEL

Deposits: ☐ None ☐ Mud ☒ **Sludge** ☐ **Debris** ☐ Grease

Silt Depth: **2** (in.) Deposits Extent: **Light**

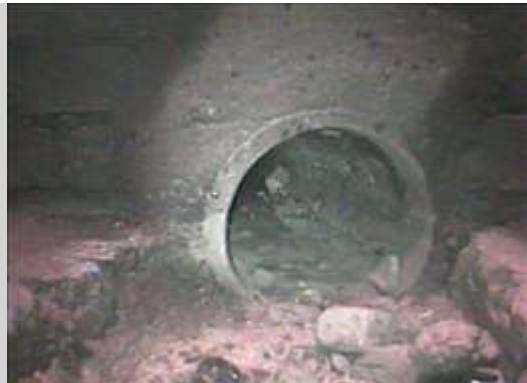
9 O'Clock Inflow

DEBRIS IN CHANNEL

Deposits: ☐ None ☐ Mud ☐ Sludge ☒ **Debris** ☐ Grease

Silt Depth: **1** (in.) Deposits Extent: **Light**
